**Cementitious Hot Water Tank Lining System**

**TANK CEMENTITIOUS RELINING**

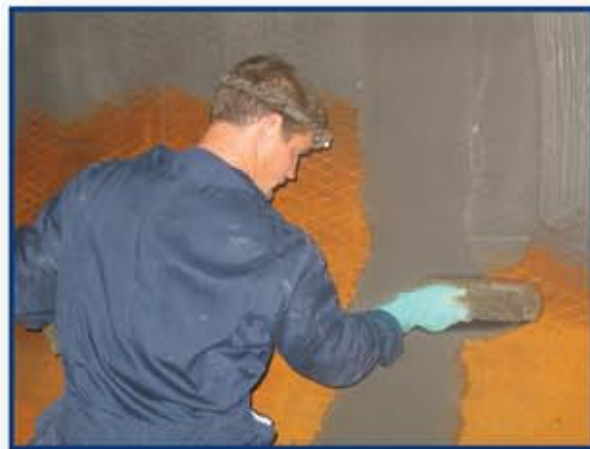
There comes a point in the productive lifespan of each hot water tank when service is needed to maintain the tanks integrity. Cementitious relining is recommended when the present lining begins to fail. Failure to reline will result in further erosion which will thin and then permeate the outer steel wall. Erosion of the outer steel tank wall will ultimately result in tank failure.

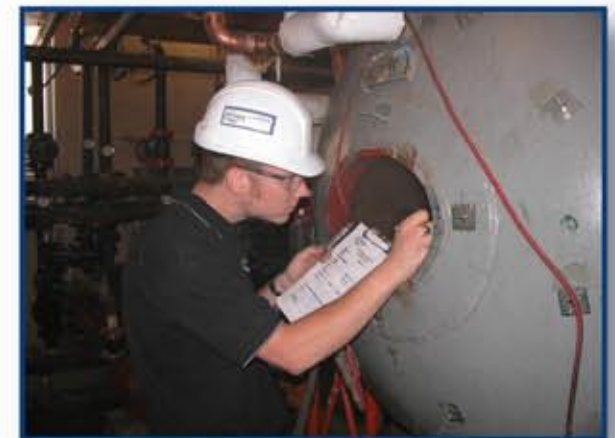
New Anode  
Spent Anode - 2 to 5 years

Most tanks fail due to a lack of protection from corrosion. Sacrificial anodes ensure protection for the steel surfaces in a storage tank that cannot be protected by the lining, such as couplings, bushings and collars. These are the most common areas for unexpected leaks. A sacrificial anode produces a small electrical current which corrodes the anode instead of the tank's unlined areas. Some anodes can be serviced from the exterior of the tank while others require entry of the vessel. Sacrificial anodes should be replaced when they are depleted and no longer protect these exposed areas.

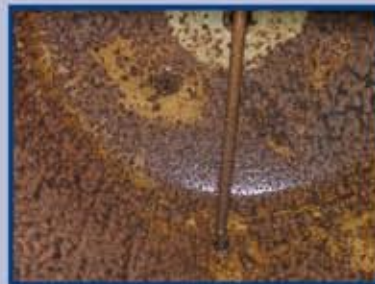
**BEFORE** A corroded and pitted Domestic Hot Water Storage Tank. If the corrosive action had continued, the tank would soon have required costly replacement.

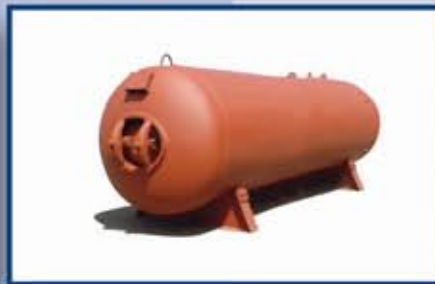
**AFTER** The finished product. A Hydrastone calcium aluminum cement lining was applied at a minimum 5/8" thickness, and further corrosion has been stopped. The tank was relined on site, and put back into service within 30 hrs.
